National Date Stamp's Guide to Reducing the Clicking Noise

The RapidPrint date stamp machine, along with most heavy duty stamper units, creates a loud click every one minute. The following document is a guide to reduce this annoying side effect:

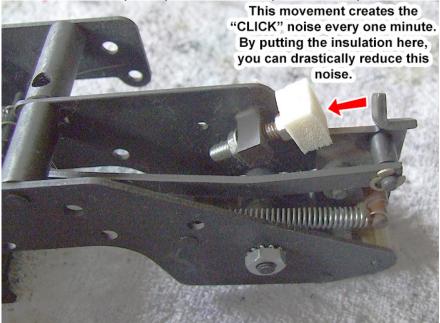
5) Adhere the newly cut piece to the top of the stop-screw as shown below:

This image shows the cause of the click along with the newly cut foam pad put in place.

NOTE: The extra space created by adding the foam pad could cause the date stamp to lose time or to start jumping dates and or time. If this happens to your date stamp, continue with the following adjustments.

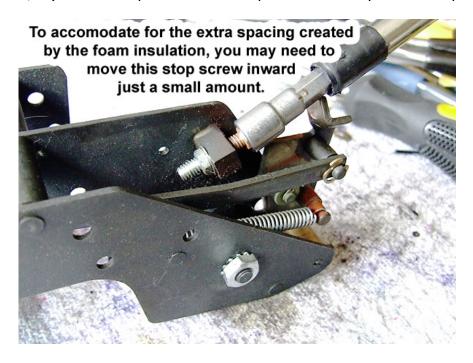
6) Remove the foam pad and adjust the stop-screw inward (approximately 1/6") to make up for the extra space created by the foam pad.

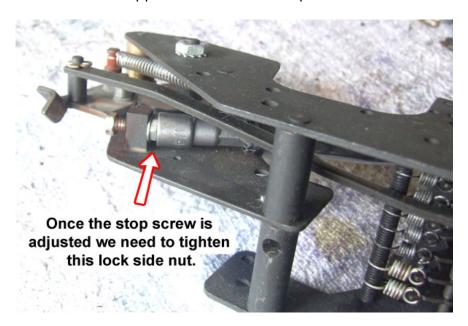
7) After the stop-screw is adjusted inward, you will now need to tighten the nut located on the opposite side of the stop-screw.

8) Now that you have made both adjustments. Put the unit back into the clock and keep an eye on the time/date for at least 24 hours. If your unit is still skipping, the stop-screw might need just a tiny bit more of adjustment.
